**Term Project - Fall 2022**  
**The Leaning Tower of Pisa: Settlement calculations**

## Term Project - Phase 2:

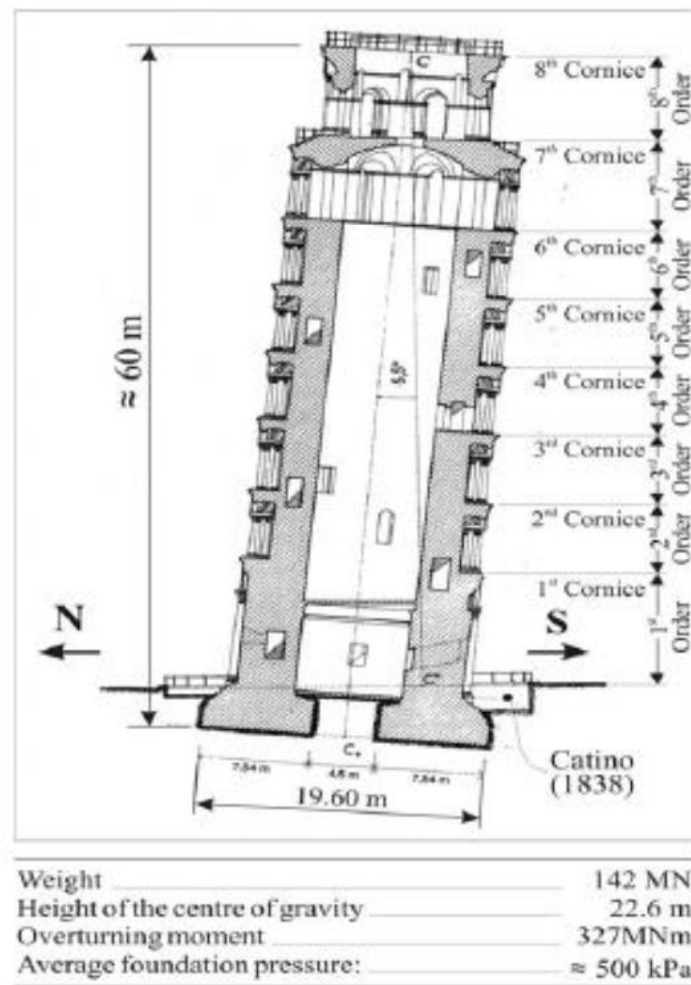
The construction of the Leaning Tower of Pisa began in 1173 and due to two long breaks, it went on for 176 years. Those breaks were most likely caused by political events. The first break came in 1178, and by that time, the construction work had only reached the 4<sup>th</sup> order of the final Tower, which is illustrated in Figure 1.

**Figure 1: Cross-section of the Tower (Burland, Jamiolkowski, & Viggiani 2009)**

The dimensions of the Tower are shown in Figure 1. The diameter of the foundation is 19.6 m and the total weight of the tower at the end of construction is 141,640 kN (~142MN) resulting in an average foundation pressure of  $q = \frac{141640kN}{\pi(\frac{19.6}{2})^2m^2} = 469kPa$  (rounded up as 500 kPa in Figure 1).

The initial tilting of the tower was caused by a variety of reasons, including distortion settlement of the sand and silt in Horizon A (Mitchell et al., 1977). Tilting progressed with the various stages of the construction and only reached the current tilt of 5.5° (Figure 1) in 1990. It is beyond the scope of this term project to fully understand the causes of the tilt or the time evolution of it. We would assume that one side of the tower experienced substantially higher load than the other and will make some simplifying assumptions to apply the Soil Mechanics principles you learned in this class. Due to the simplifying assumptions and data taken from two different sources, the actual differential settlement value would vary from the one you will be calculating as a part of this project.

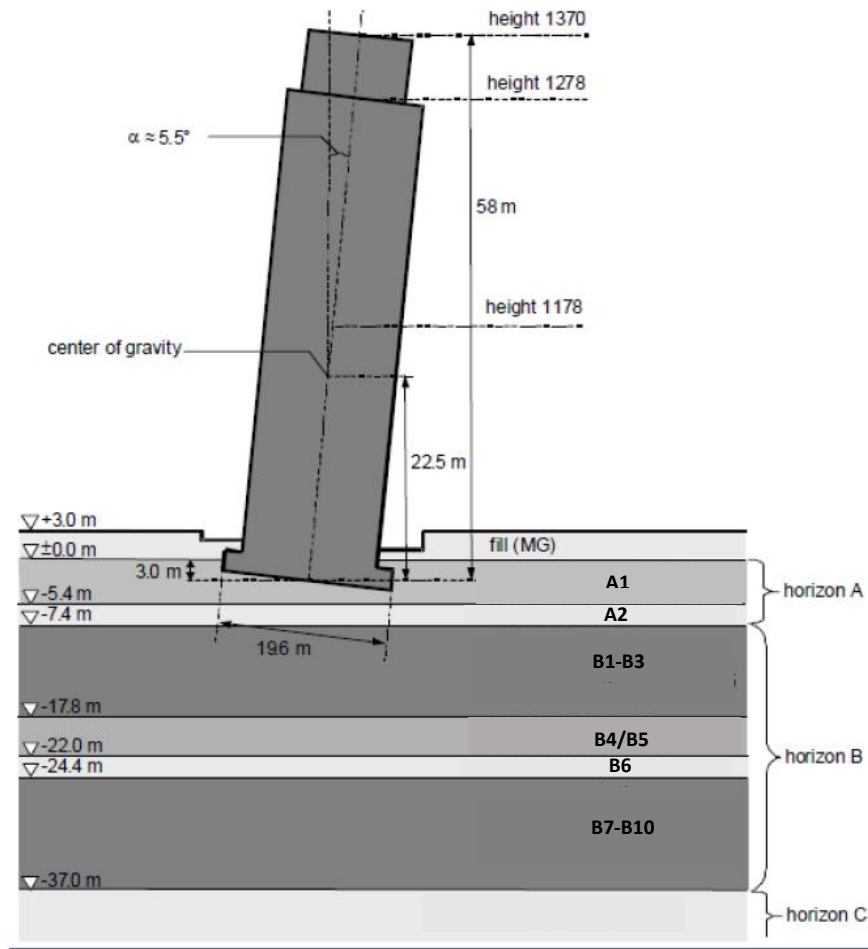
Figure 2: Geology of the subsoil beneath the Tower (Leoni & Vermeer 2002)

- The fill layer at the top of Figure 2 can be ignored, as it was added later in the history of the tower.
- The **groundwater table** is located at 2 m below the ground surface ( $\pm 0.0$  m) and the **foundation** is at 3 m below the ground surface.
- The tower is upright with a **circular** foundation. The stress increase in the midpoint of each clay layer can be calculated using the approach you learned in Module 6 (point under the center of a circular footing).
- Assume that the **north side is experiencing 65%** of that stress increase ( $\Delta\sigma_z$ ), while the **south side is experiencing 135%** of the stress increase. That means you can assume the

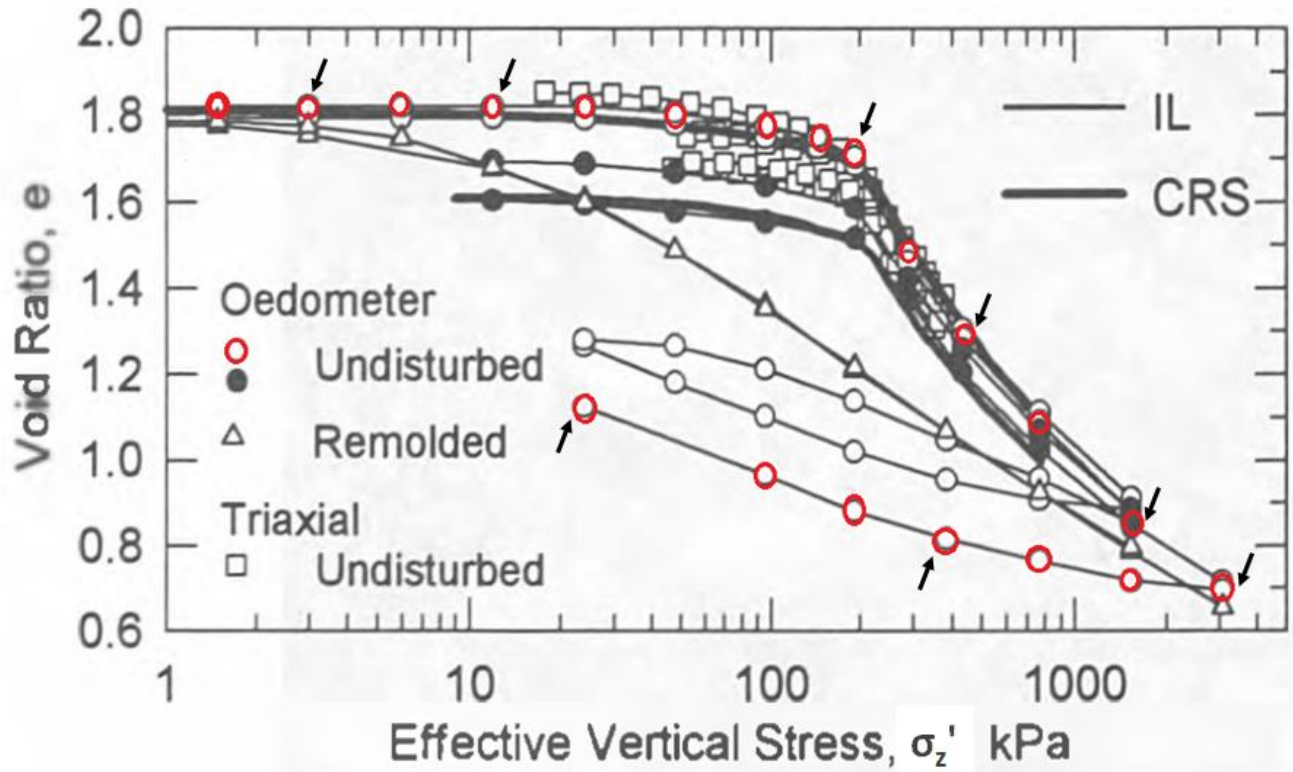
The consolidation data for the clay layer 2 is given in Figure 3 below. You will use the red dataset (shown using the arrowheads) to determine the necessary parameters to complete Table 2 shown below. **A clean graph of the red dataset has been provided in the attached Excel file titled “Oedometer\_test\_results”.**

Figure 3: 1-D Oedometer test results for clay layer 2 (Mesri et al. 1997)
