**Term Project - Fall 2022**  
**The Leaning Tower of Pisa: Settlement calculations**

## Term Project - Phase 3:

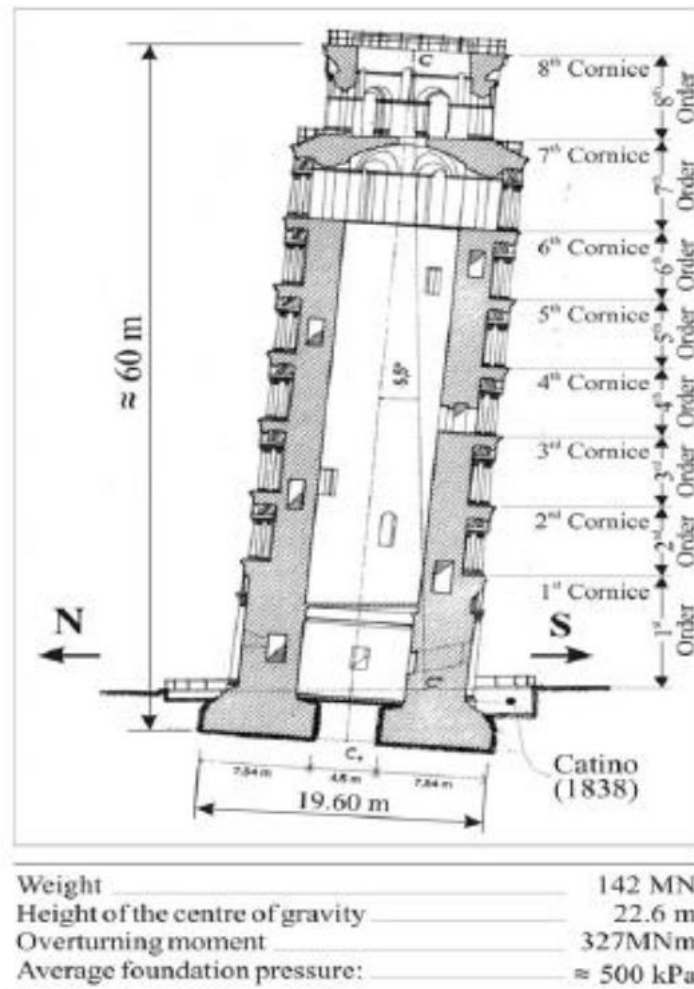
**Figure 1: Cross-section of the Tower (Burland, Jamiolkowski, & Viggiani, 2009)**

The construction of the Leaning Tower of Pisa began in 1173 and due to two long breaks, it went on for 176 years. Those breaks were most likely caused by political events. The first break came in 1178, and by that time, the construction work had only reached the 4<sup>th</sup> order of the final Tower, which is illustrated in Figure 1.

The dimensions of the Tower are shown in Figure 1. The diameter of the foundation is 19.6 m and the total weight of the tower at the end of construction is 141,640 kN (~142MN) resulting in an average foundation pressure of  $q = \frac{141640kN}{\pi(\frac{19.6}{2})^2m^2} = 469kPa$  (rounded up as 500 kPa in Figure 1).

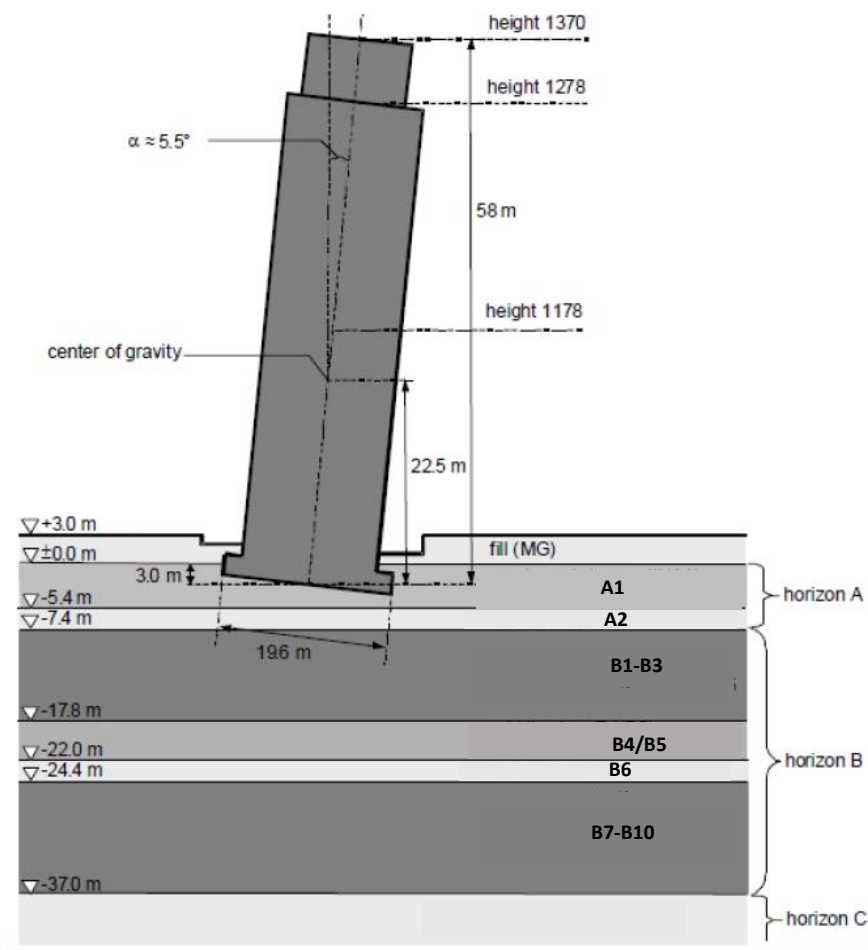
Figure 2: Geology of the subsoil beneath the Tower (Leoni & Vermeer 2002)
